Attachment D
Roof Management Reports

Roof Management Report

CITY OF VICTORVILLE

AVENAL TREATMENT PLANT

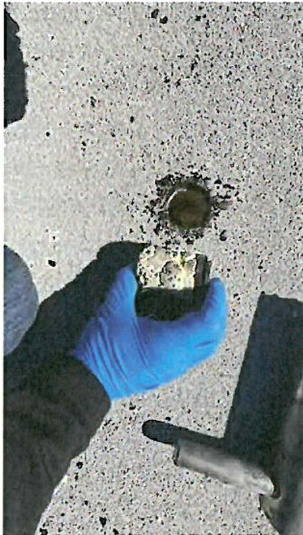
3

The roof was core tested to determine the components of the roofing system from the deck up.

The roof assembly for this building consists of a:

- Metal Deck
- ISO Insulation
- Built Up Roof

This core test hole was patched and is 100% watertight. The core sample was retained for our internal testing.

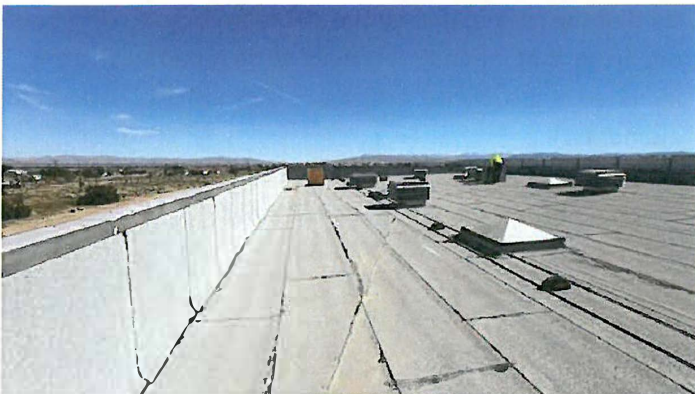
7

This type of roof consist of multiple layers of rolls that are made of waterproof with asphalt. Because this type of roof relies on adhesive or asphalt waterproofing in between seams, it is difficult to keep this type of roof water tight as the roof system ages. On the roof of this type with the amount of penetrations, and considering the age of the roof, a permanent solution is required in order to keep this building watertight in the long term.

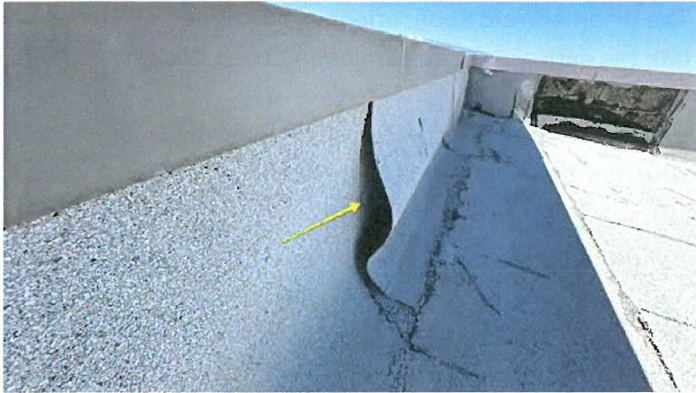
8

There are several areas on this roof that have delamination of roofing material that have caused openings, allowing water to enter the building. This is typically caused by building movement, expansion or contraction in the roof system, lack of attachment between roof system components, or material incompatibility. This can also occur in high wind areas if the roof material was incorrectly attached or adhered.

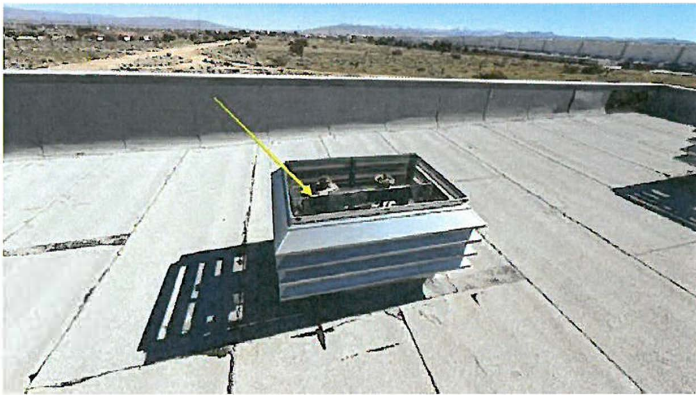
9

Covers, pans, or missing components from rooftop equipment could be allowing water to enter the building. It is recommended to ensure all rooftop equipment is functioning properly, and all covers are sealed and water-proofed during regular maintenance.

If replacement is required, it is recommended that rooftop accessory or equipment installation is coordinated with the roofing contractor to be performed in sequence with roof system installation.

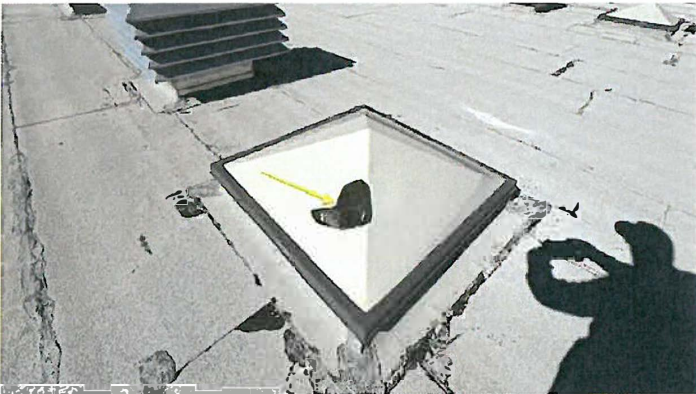
Based on visual observation, it appears the skylights are deteriorating and could be contributing to water leaks into the building. It is recommended to remove existing skylights and install new curb mounted skylights that are safety rated. These can be specified with the roofing project, and the skylights will be the last item to install after the roof system is completed.

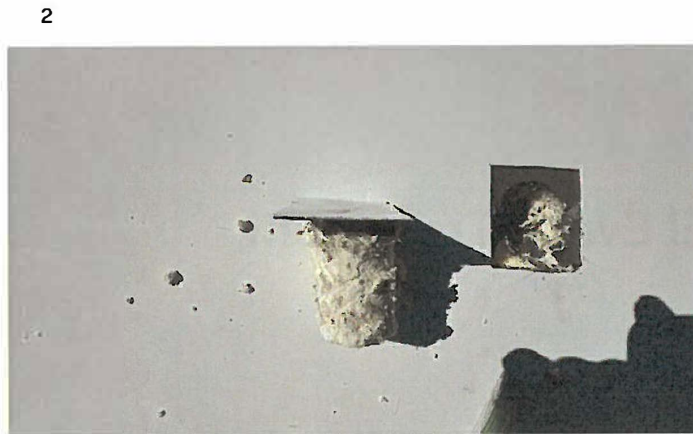
The roof was core tested to determine the components of the roofing system from the deck up.

The roof assembly for this building consists of a:

- Metal Roof Deck
- ISO Insulation
- Single Ply Membrane

This core test hole was patched and is 100% watertight. The core sample was retained for our internal testing.

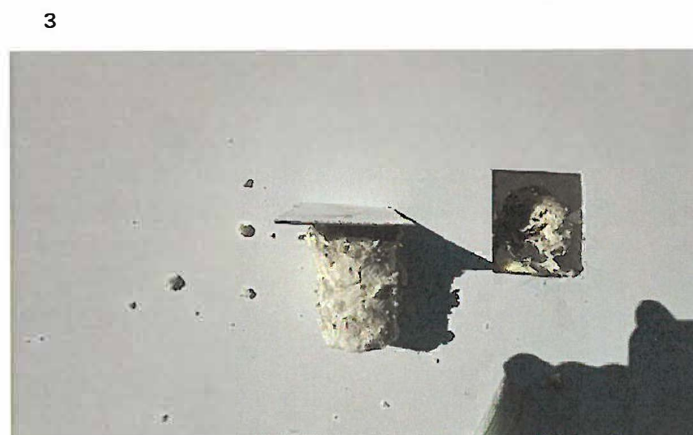
4

The omission or lack of a substrate board installed between the insulation and the single ply membrane is a cause for concern.

Insulation boards are not designed to withstand traffic. This puts unnecessary stress on roof membranes, such as a single ply. Most industry standards require a substrate board between insulation and single ply membranes. This is a cause of premature failure of single ply membranes.

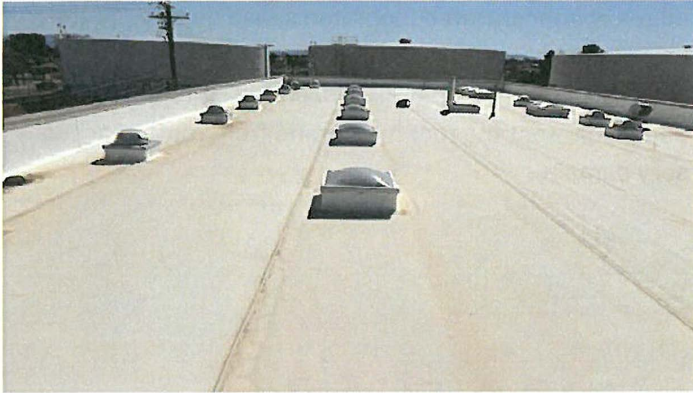
5

Single ply membranes installed on roofs consist of thin synthetic membranes that are typically between 30 and 80 mils thick.

Typical problems with thin plastic synthetic membranes consist of the following

- Uv deterioration of plastic membrane

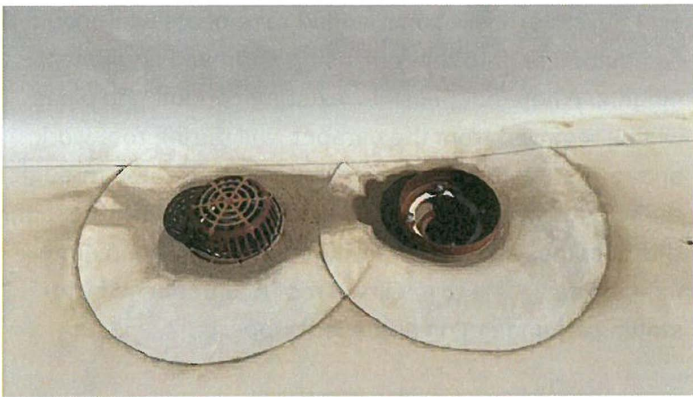
6

Water drains from this roof through flush mount drains, which can often lead to leaks. These leaks happen because the attachment of the roofing material solely depends on the tightness of the drains compression ring and bolts. Over time, changes in temperature can cause the roof material to separate from the drain, resulting in leaks. WeatherWeld is designed to prevent these leaks by sealing directly to the sides of the drain bowl, creating triple redundancy. Missing drain screens need replacement.

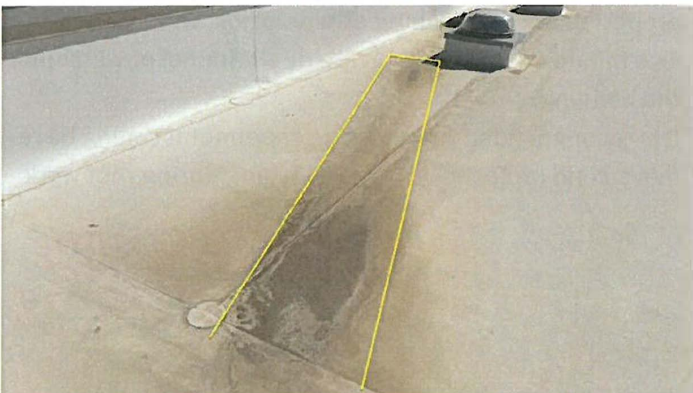
7

Synthetic membranes often prematurely fail due to UV exposure.

Typically, synthetic membranes require protection in the form of paint, or some type of coating in order to remain UV stable.

In the case of single ply membranes, deterioration of the field membrane due to UV exposure is one of the leading causes of premature failures of this type of membranes. As the roof membrane reaches the end of their useful life, deterioration of the synthetic membranes becomes visible.

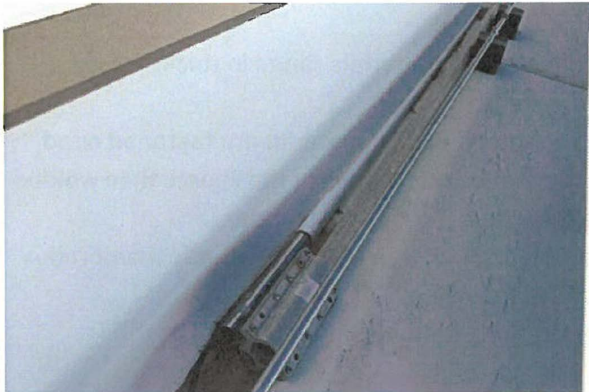
8

Rooftop accessories for equipment that is directly placed on the roof membrane can cause premature failure. Sharp edges or concentrated loads can cause damage to the roof membrane. It is recommended to install approved rooftop supports with proper flashings or roof protection pads to protect the roof membrane from rooftop accessory damage.

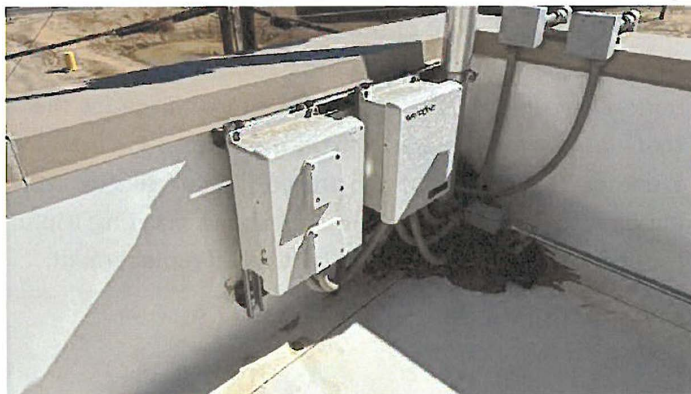
9

Equipment and pipes that are bolted to parapet walls are a potential source of roof leaks into the building. Whenever possible, it is recommended to relocate wall-mounted equipment onto the roof, using approved equipment mounts. Where not possible, existing conduit and pipes will be removed from the parapet wall during roof work, and re-mounted. Anytime equipment penetrates through the roof membrane either on a wall or the field of the roof, this becomes an area that will require constant maintenance. The goal is to minimize roof maintenance by installing equipment on approved supports.

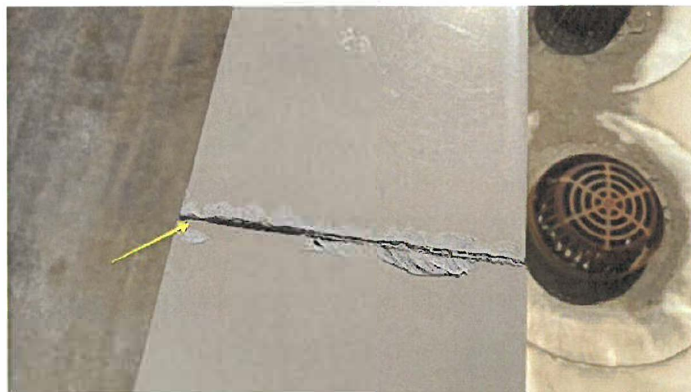
10

Perimeter flashings show signs of separation or delamination at sheet metal joints. This could be caused by improper fastening, flashing deterioration, wind, or adhesive failures. This condition is a direct funnel of water into the building.

It is recommended that existing sheetmetal coping be removed and replaced with new flashing during roof work.

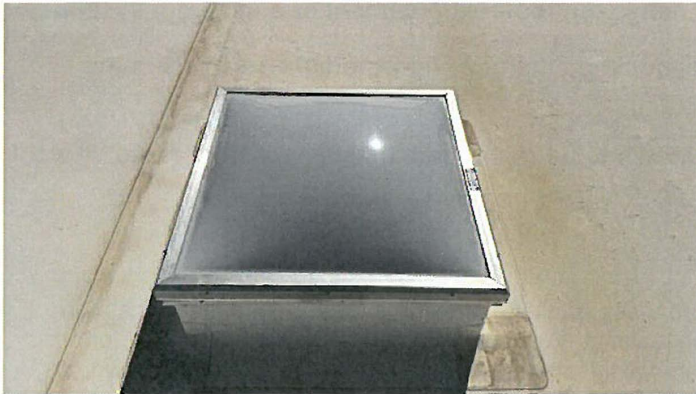
11

Based on visual observation, it appears the skylights are deteriorating and could be contributing to water leaks into the building. It is recommended to remove existing skylights, and install new curb mounted skylights that are safety rated. These can be specified with the roofing project, and the skylights will be the last item to install after the roof system is completed.

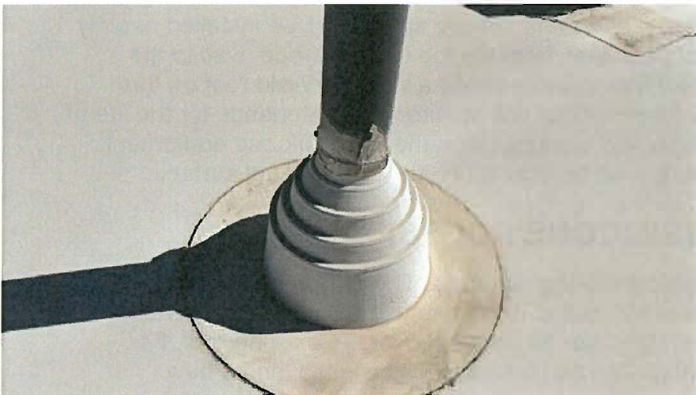
Rooftop penetrations such as pipes and vent/exhaust fans are installed in the field of the roof. These types of penetrations are difficult to keep water-tight and require consistent use of repair materials as seen in this photo. Existing roof penetrations will be encapsulated with WeatherWeld during roof work, making a seamless transition between the penetration and the field the roof. All rooftop penetrations will have sheet metal storm collars installed above flashings where applicable.

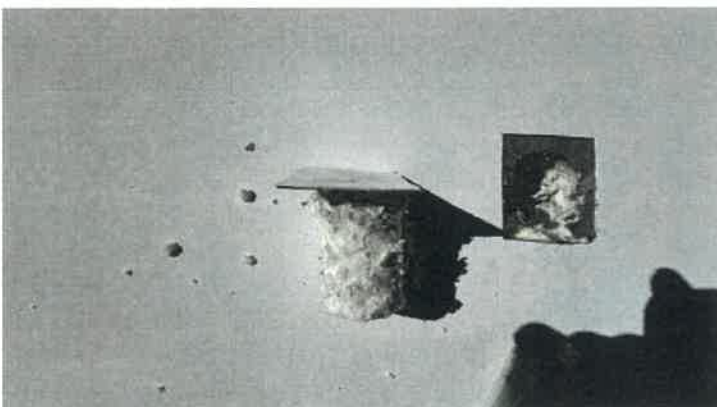
4

The roof was core tested to determine the components of the roofing system from the deck up.

The roof assembly for this building consists of a:

- Metal Deck
- ISO Insulation
- Single Ply Roof Membrane

This core test hole was patched and is 100% watertight. The core sample was retained for our internal testing.

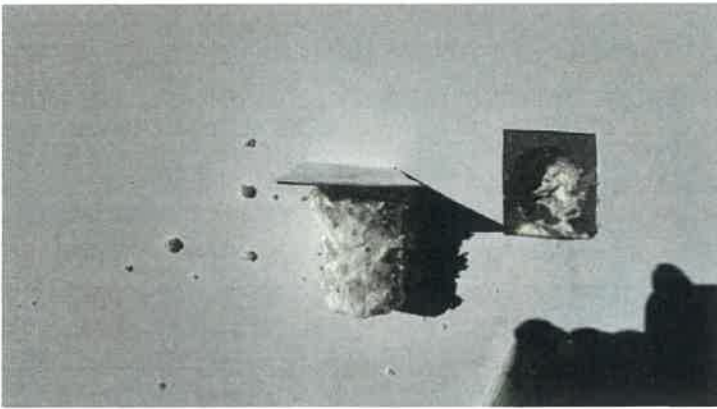
5

The omission or lack of a substrate board installed between the insulation and the single ply membrane is a cause of concern. Insulation boards are not designed to withstand traffic. This puts un-needed stress on roof membranes, such as a single ply.

Most industry standards require a substrate board between insulation and single ply membranes.

This is a cause of premature failure of single ply membranes.

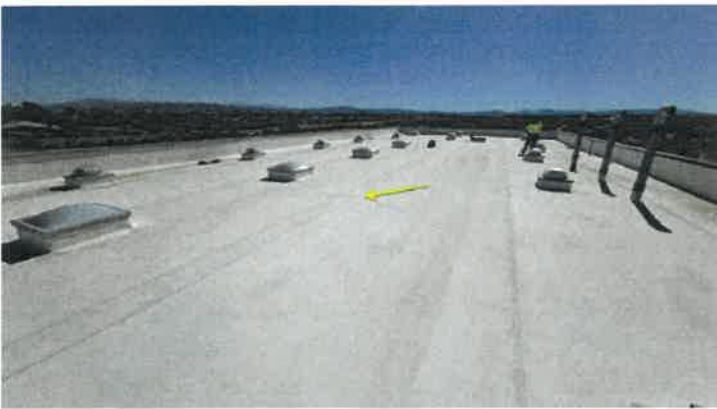
6

Single ply membranes installed on roofs consist of thin synthetic membranes that are typically between 30 and 80 mils thick.

Thin, wide sheets of synthetic plastic material are fastened or adhered to the roof assembly or deck underneath, then welded at the edges with a 500° hot air welder, creating miles of welded joints.

Typical problems with thin plastic synthetic membranes consist of the following

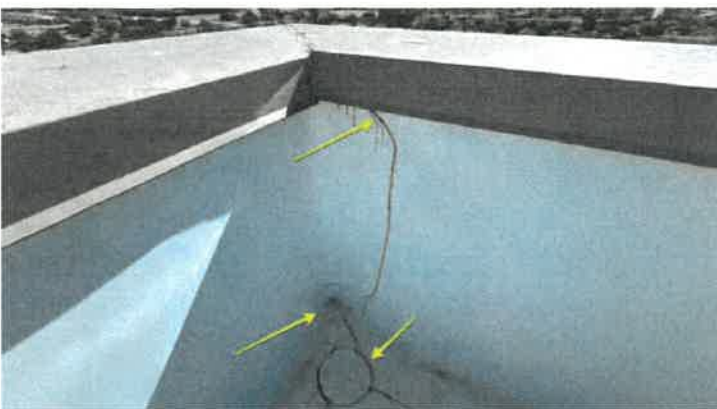
7

Synthetic sheet based membranes, such as single ply, rely on cuts, seams, and welds to conform roll based sheets to non-flat surfaces. In this case, a roll had to be cut and seamed by hand with a hot air welder to conform to this detail. As you can see in the photo, the work is sloppy, does not meet industry standards, and could be causing leaks into the building.

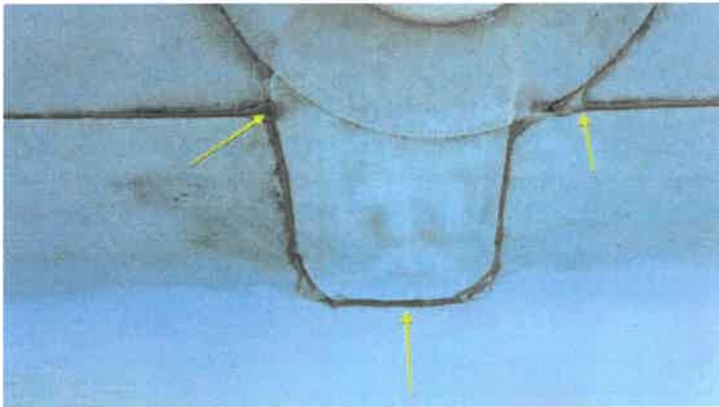
8

Synthetic sheet-based membranes, such as single ply, require patches to be installed at every sheet intersection. This creates hundreds or even thousands of spot repairs that must be installed on the roof before the project is considered finished.

This is also one of the largest failure points or causes of premature failure of a single ply membrane. These areas require weakening the membrane with a hot air welder to install patches.

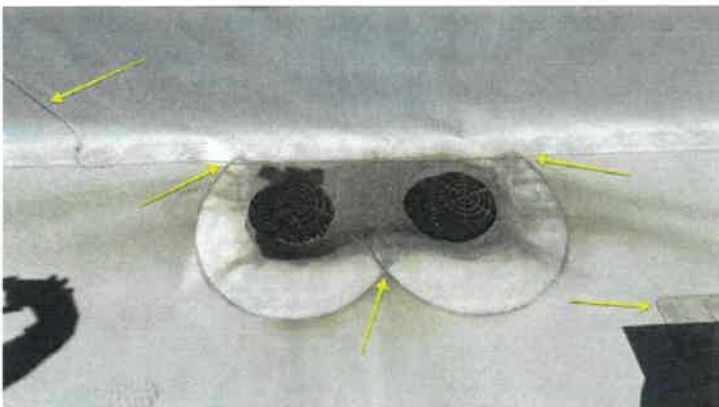
9

Water drains from this roof through flush mount drains, which can often lead to leaks. These leaks happen because the attachment of the roofing material solely depends on the tightness of the drains compression ring and bolts. Over time, changes in temperature can cause the roof material to separate from the drain, resulting in leaks. WeatherWeld is designed to prevent these leaks by sealing directly to the sides of the drain bowl, creating triple redundancy.

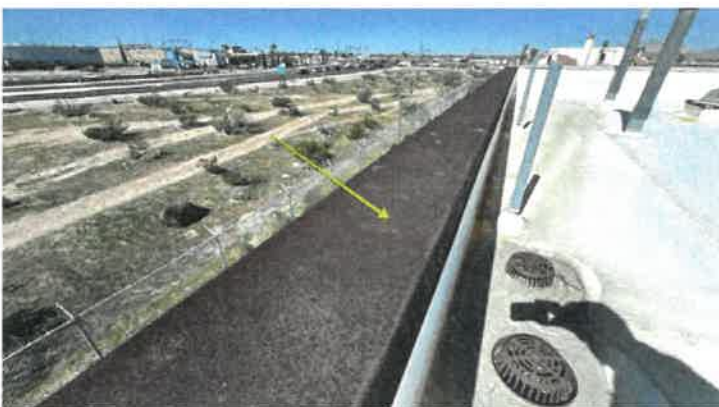
10

The perimeter of this building consists of a concrete parapet wall that is roofed to the top the wall.

The WeatherWeld applications are designed to encapsulate the entire parapet, eliminating base flashing or wall leaks.

Existing sheetmetal coping will be removed and replaced with new flashing during roof work.

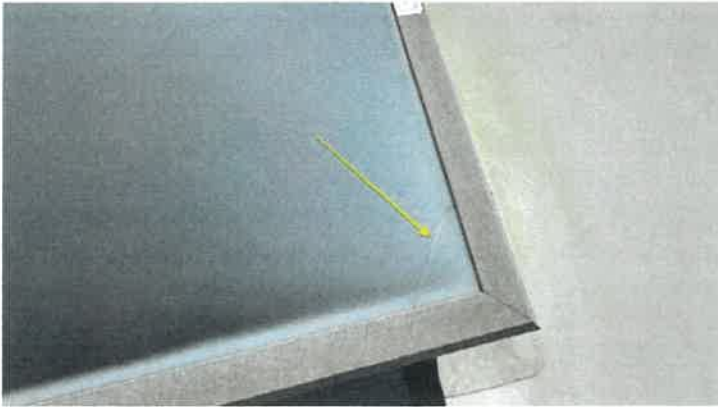
Based on visual observation, it appears the skylights are deteriorating and could be contributing to water leaks into the building. It is recommended to remove existing skylights and install new curb mounted skylights that are safety rated. These can be specified with the roofing project, and the skylights will be the last item to install after the roof system is completed.

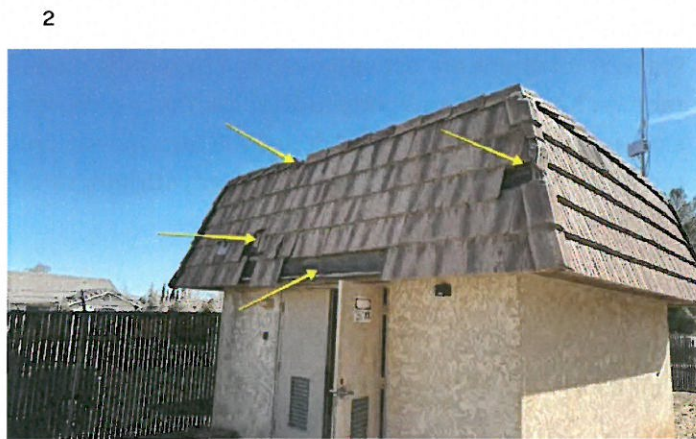
This building has a tile mansard roof wrapping around the perimeter of the building with a flat roof section above. The tile is broken or missing in several areas exposing the waterproofing, felt, and the structure underneath to the elements.

It is recommended to remove the entire tile roof section and replace with a durable roof system that matches the aesthetic requirements.

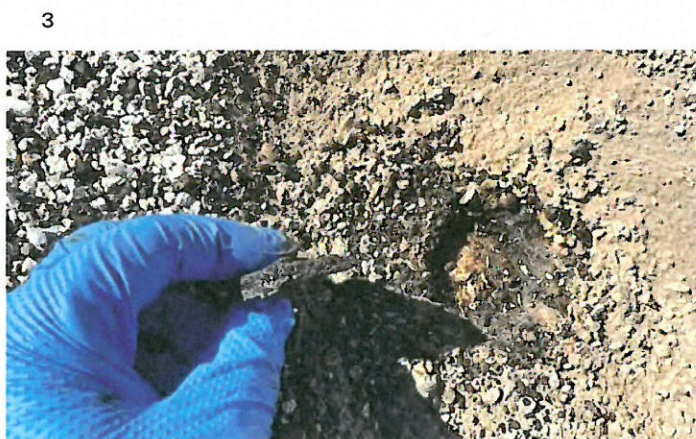
4

The roof was core tested to determine the components of the roofing system from the deck up.

The roof assembly for this building consists of a:

- Plywood Roof Deck
- Gravel Surfaced Built Up Roof

This core test hole was patched and is 100% watertight. The core sample was retained for our internal testing.

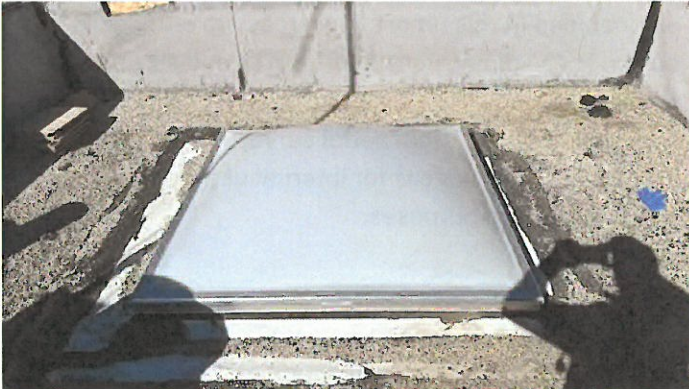
5

Based on visual observation, it appears the skylights are mounted low and could be contributing to water leaks into the building. It is recommended to remove existing skylights, install new curb of sufficient height, and install new safety rated skylights with vandalism/fall protection bars. These can be specified with the roofing project, and the skylights will be the last item to install after the roof system is completed.

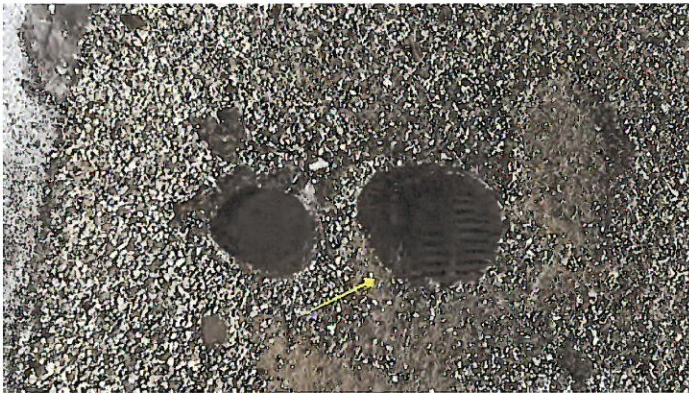
6

This building has flush mount plastic roof drains installed.

Plastic roof drains are not approved by any roofing manufacturer because the inability to attach with the compression ring. Existing plastic roof drains will be removed, and replaced with cast iron flush mount drains with integrated overflows.

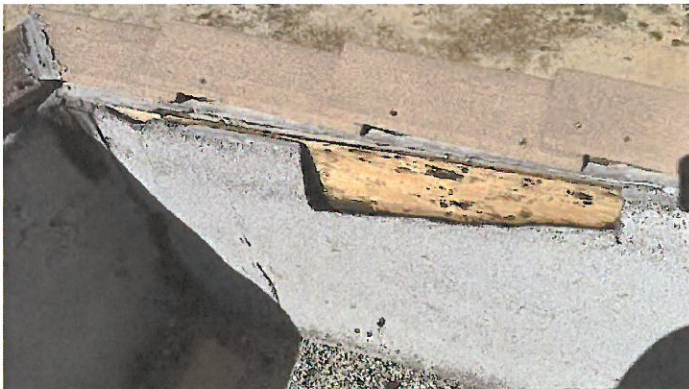
7

There are several areas on this roof that have delamination of roofing material, leaving openings that allow water to enter the building. This is typically caused by building movement, expansion or contraction in the roof system, lack of attachment between roof system components, or material incompatibility. This can also occur in high wind areas if the roof material was incorrectly attached or adhered.

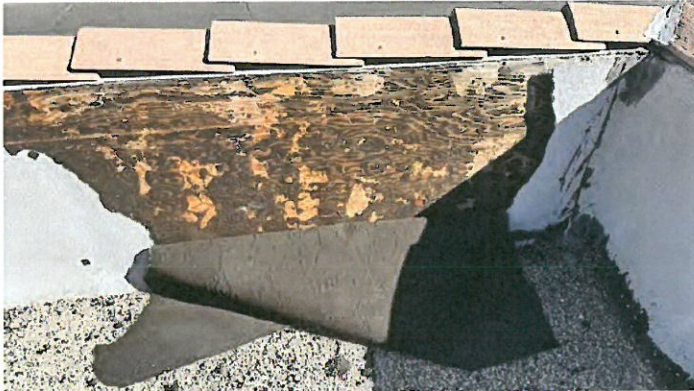
8

There are several areas on this roof that have delamination of roofing material, leaving openings allowing water to enter the building. This is typically caused by building movement, expansion or contraction in the roof system, lack of attachment between roof system components, or material incompatibility. This can also occur in high wind areas if the roof material was incorrectly attached or adhered.

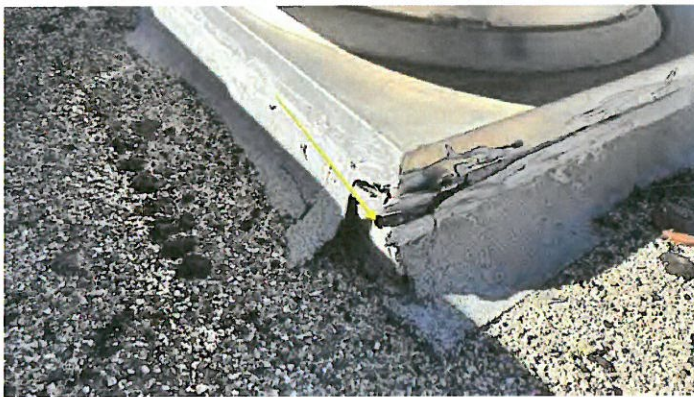
Roofing materials show signs of deterioration. This photo shows an area of the roof that has deteriorated completely, allowing water to funnel directly into the building. It is recommended to remove and replace all deteriorated roof areas during roof work to ensure that building remains watertight

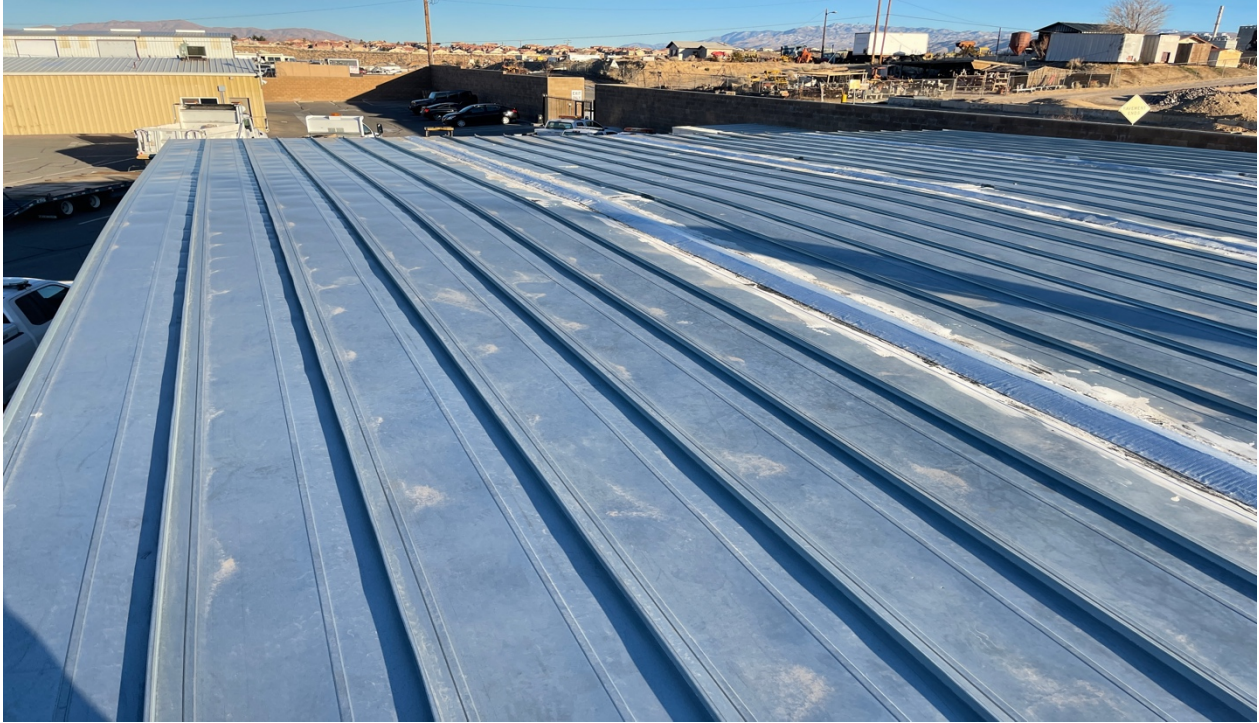
Standing seam metal consists of sheet metal panels with seams that are crimped and sealed every 12-15 inches. Sheet metal panels are attached to the substrate using sheet metal screws with rubber washers. The panels on this building are thin gauge sheet metal and should be removed down to the plywood deck in order to start over with this roof and install a strong seamless roof

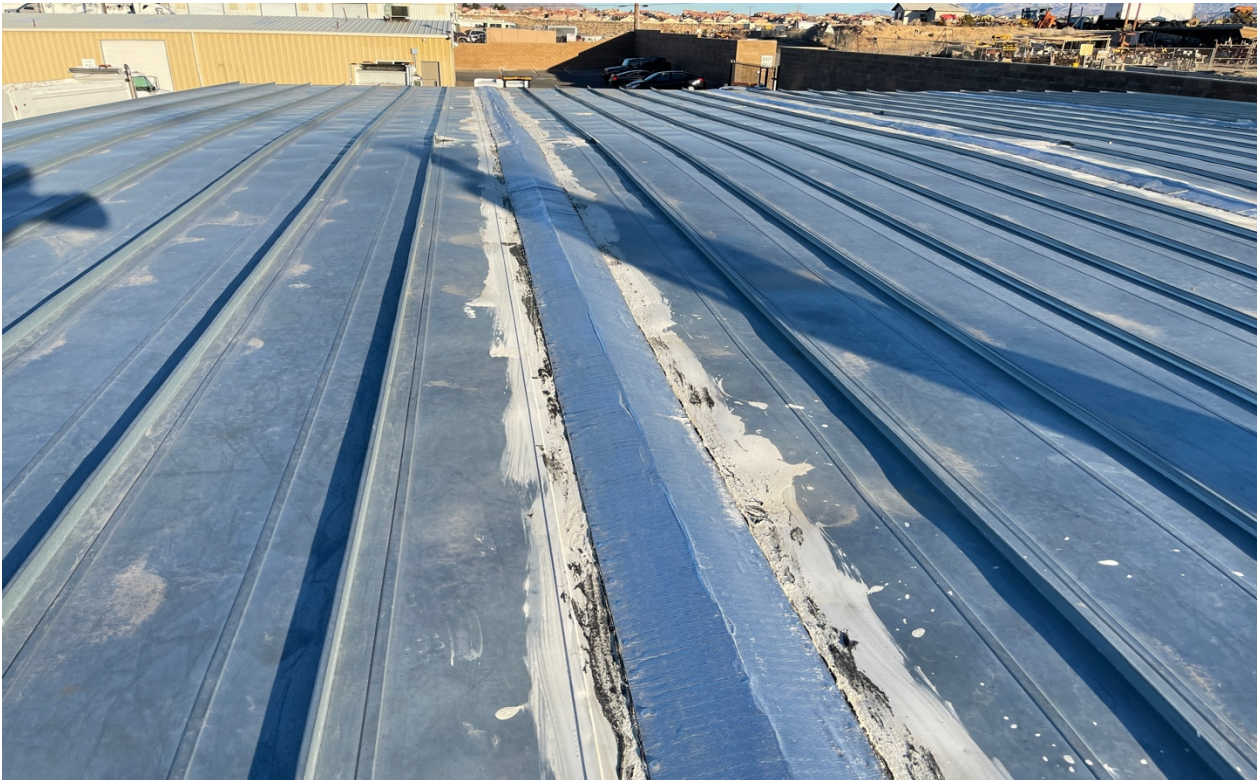
There is a cap on the joint where the buildings are joined which is a source of leaks. The picture above shows repairs made with temporary mastic, which is not solving the problem.

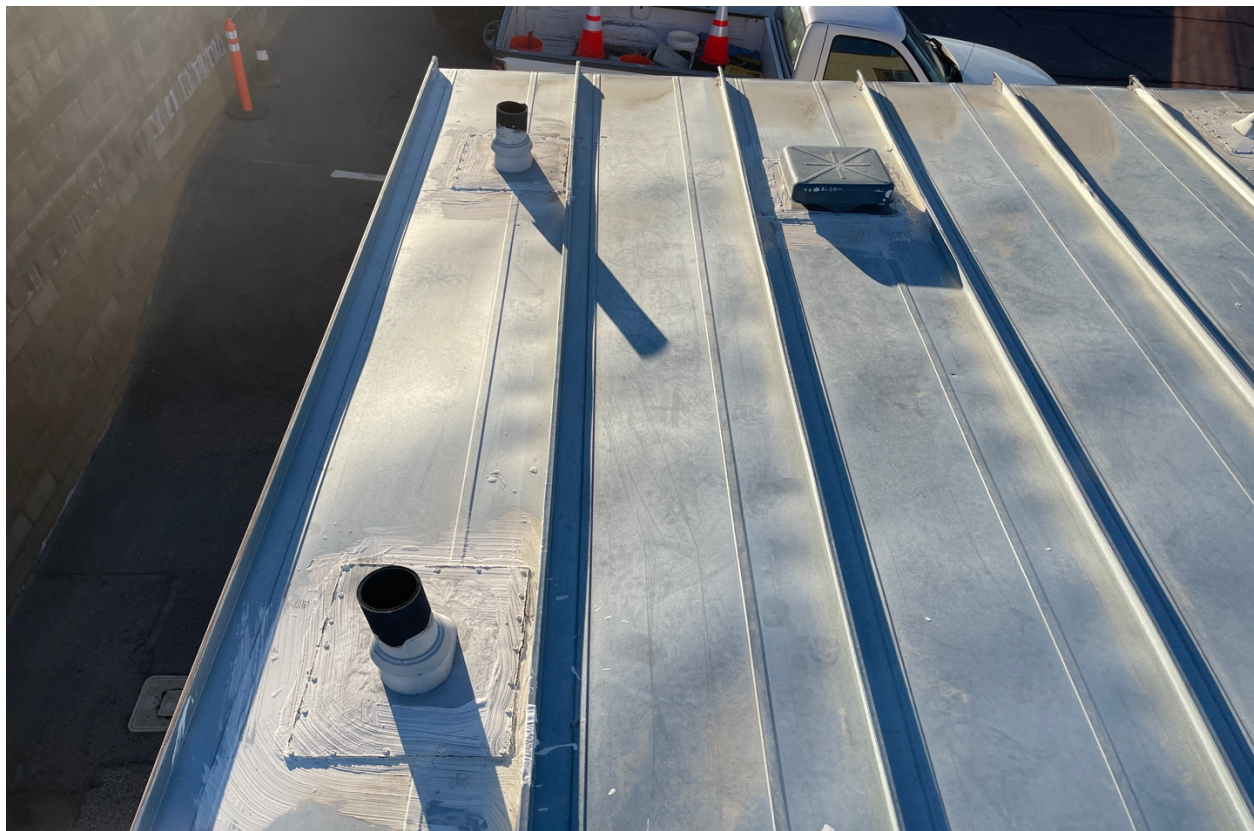
The building drains to the edge and has a few vent penetrations which also have been repaired with temporary mastic. Penetration flashing will be encapsulated during roof work.

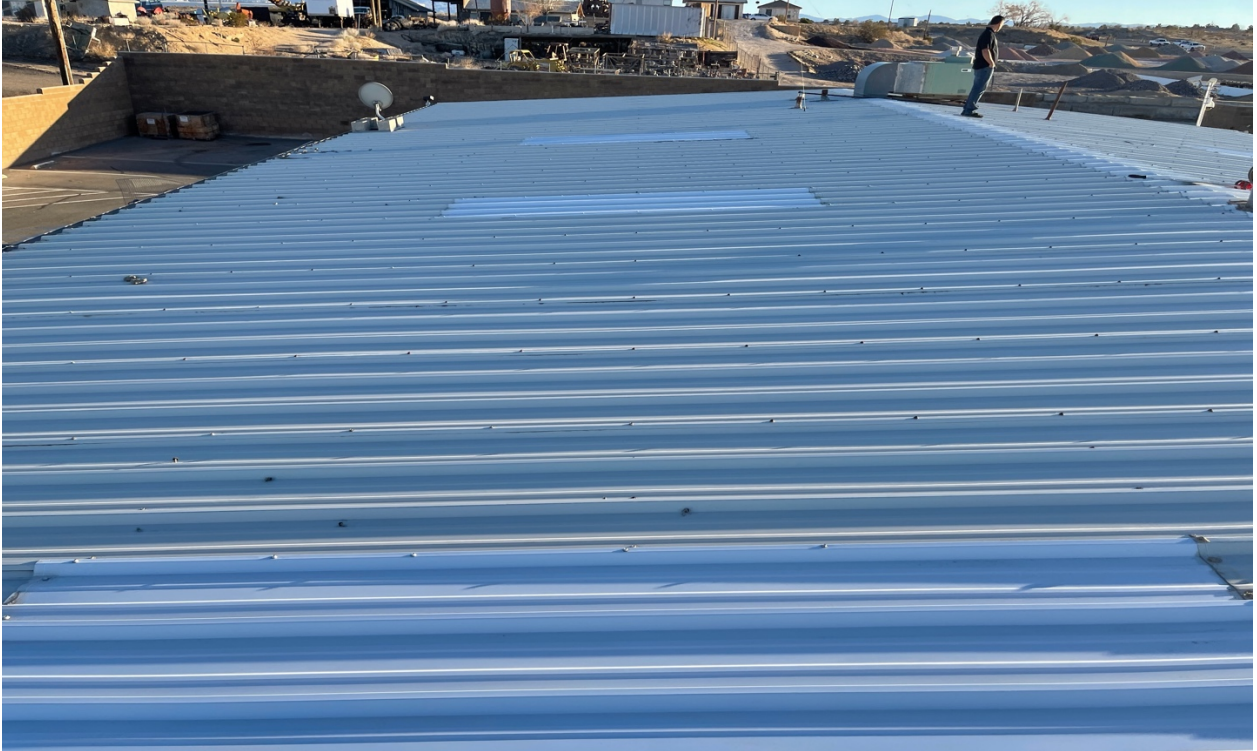
Metal panels are attached to the substrate using sheet metal screws with rubber washers. There are 3 places where metal leaks: fasteners, seams, and terminations.

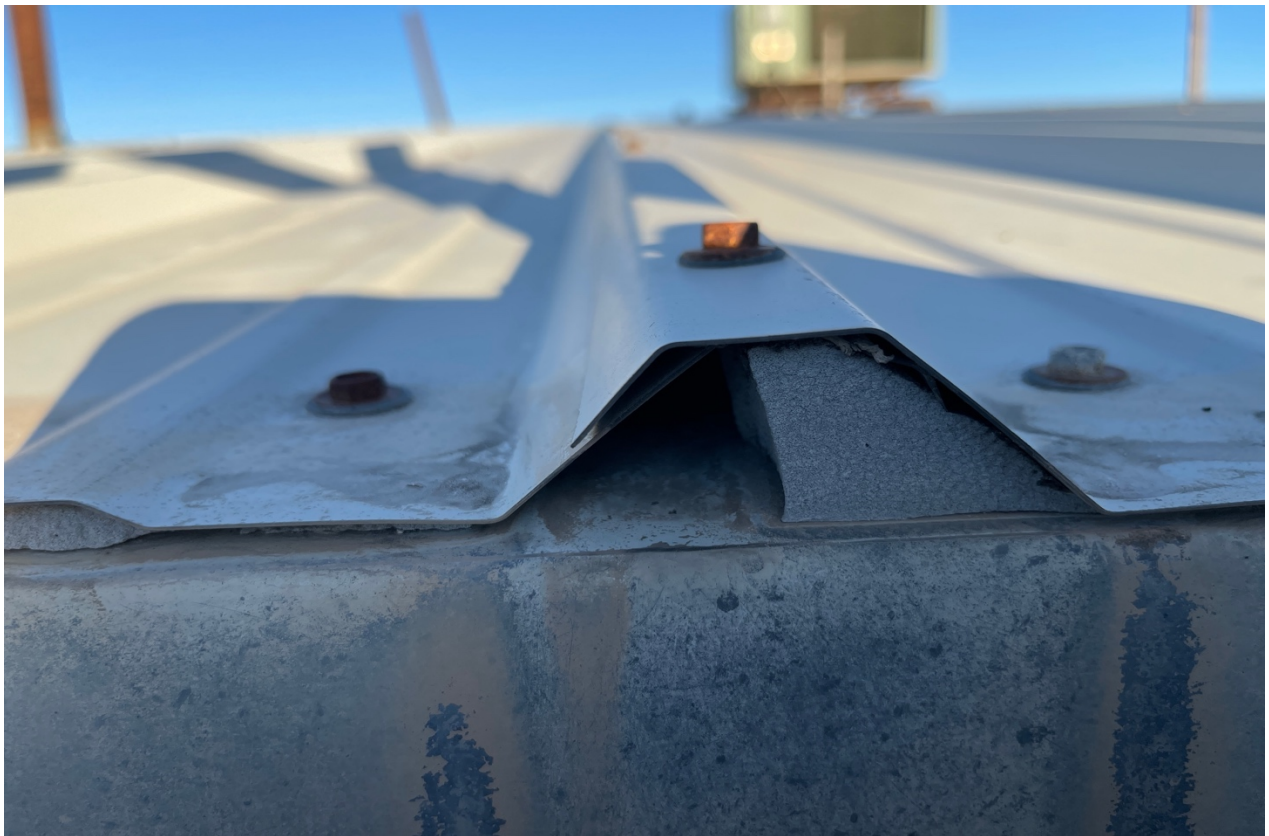
The rubber seals on fasteners wear out quickly due to expansion and contraction and panel movement.

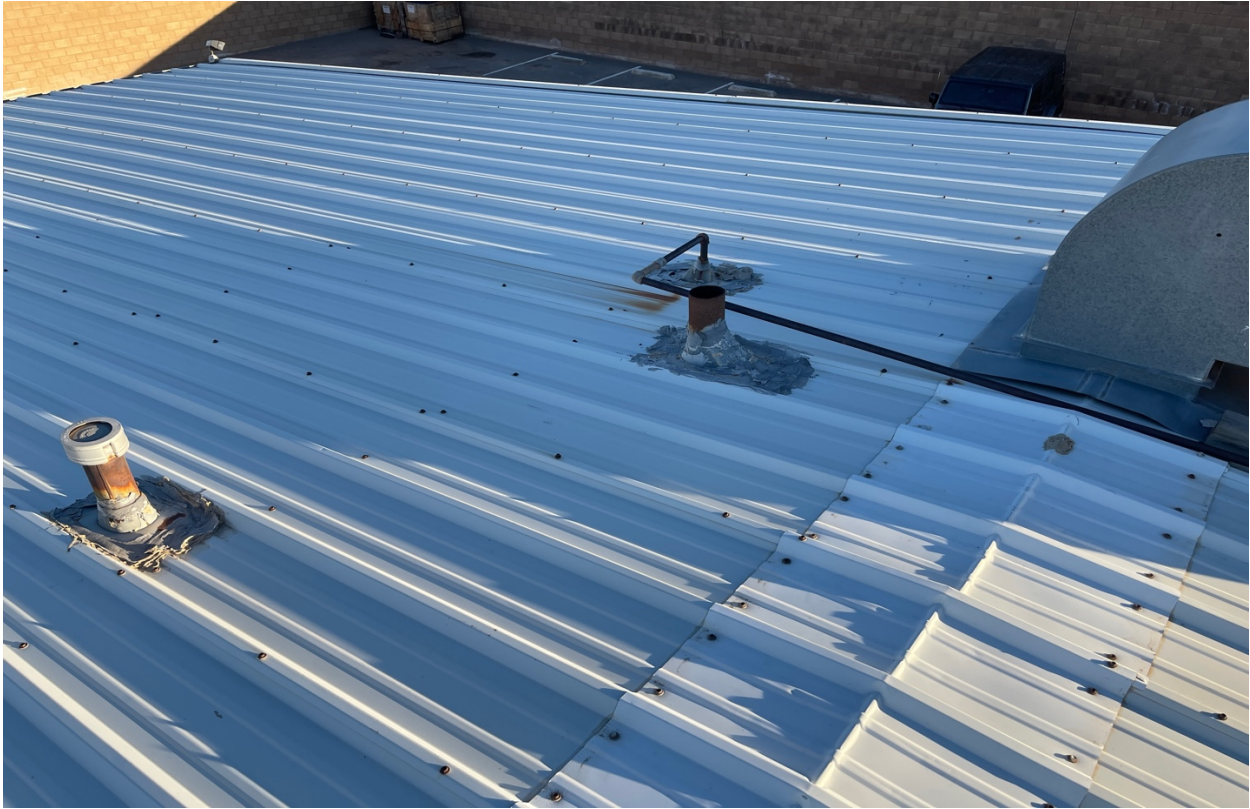
The building has a few vent penetrations which have been repaired with temporary mastic. Encapsulating these penetration flashings will create a roof that is one seamless piece and prevent leaks.

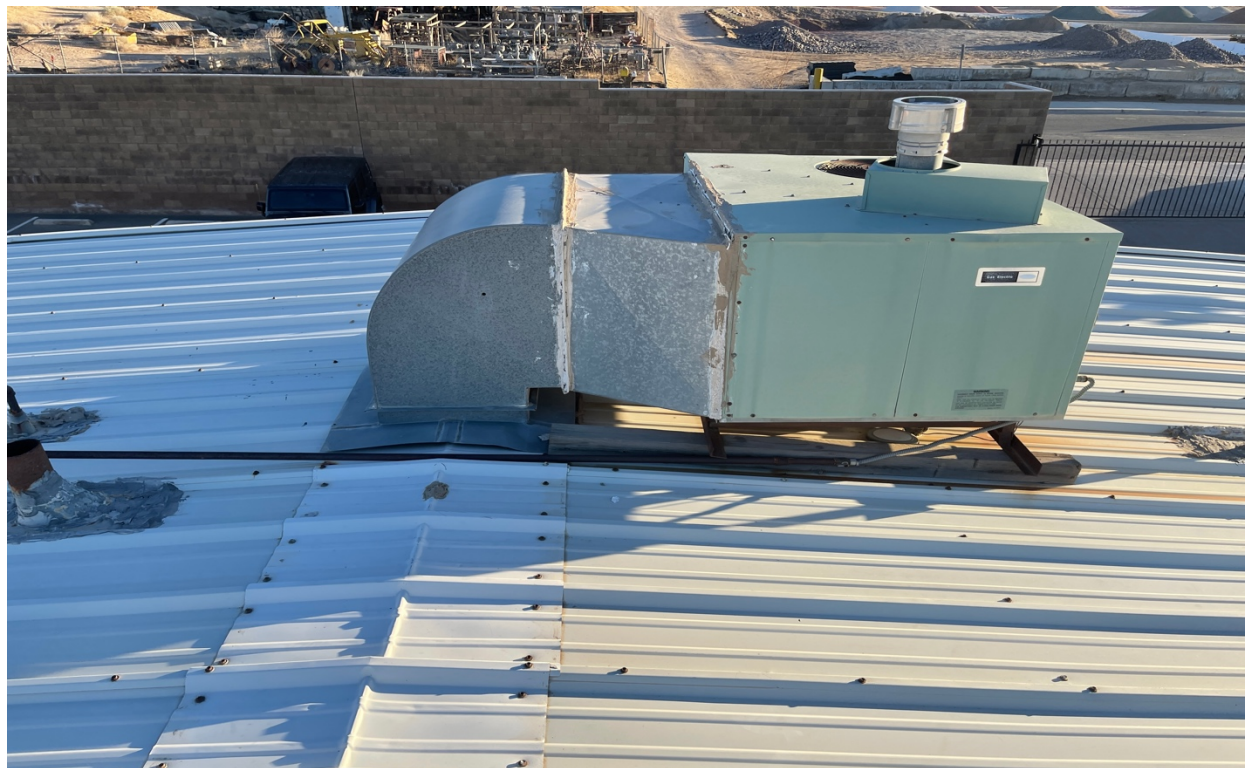
The HVAC unit is sleeper mounted and external ducts that lead into the building. This unit is going to be removed during roof work.

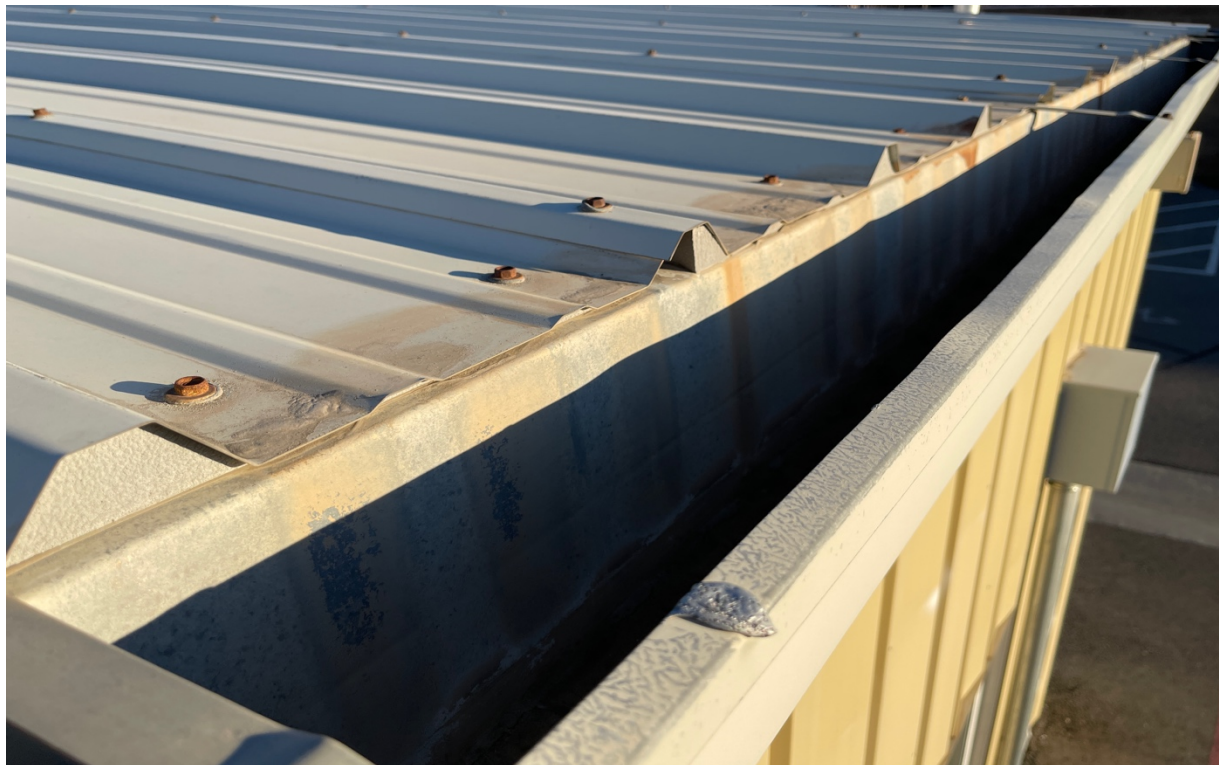
The building drains to gutters that appear to be in fair condition.
